U.S. Fish & Wildlife Service

Underground fuel release at Midway Atoll:

02/18/2003 Update

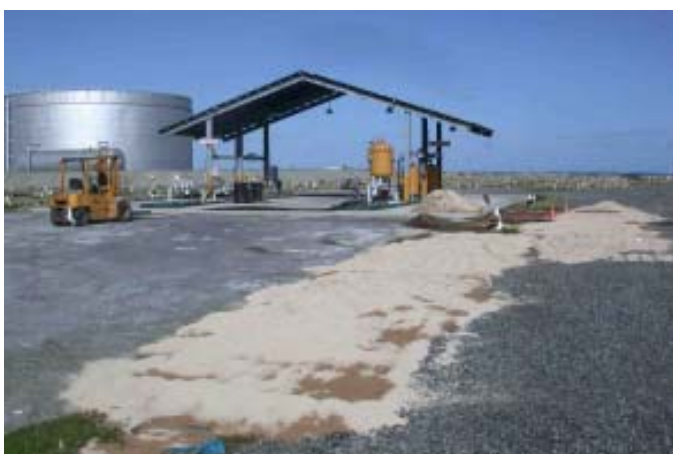
02/05: After determining that the fuel tank was not the source of the leak, FWS and GeoEngineers, Inc., began testing the multitude of pipelines leading from the tank to various sites on Sand Island. A small amount of fuel bubbling to the surface near the fill stand across the road from the fuel tank provided the first visual evidence of the leak.

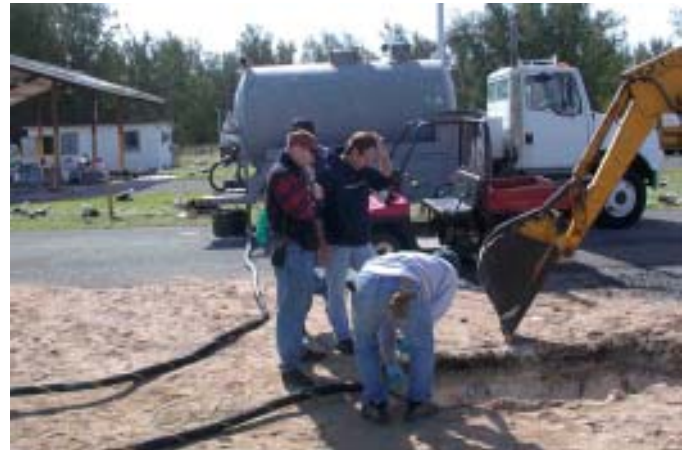
Inside the vault was an 8" fuel line and a 2" steel nipple, capped with an aluminum camlock fitting. The camlock fitting was badly corroded. Opening the valve allowed fuel to flow from the nipple.

A steel cap was secured to the nipple and additional testing showed no further leakage.

Through a detailed review of fuel farm records, GeoEngineers, Inc., has determined that approximately 100,000 gallons of JP-5 were released through the corroded fitting.
